Technical and product information

Repair methods: Peugeot Partner II

Peugeot Partner II 1.6 HDi 75/95 HP since 02/2012

AIR INTAKE CIRCUIT

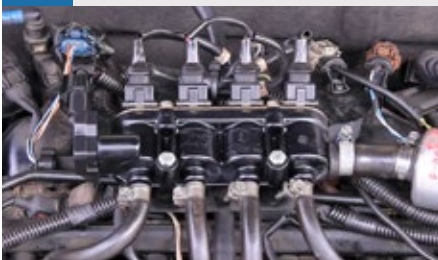
1

Original rail

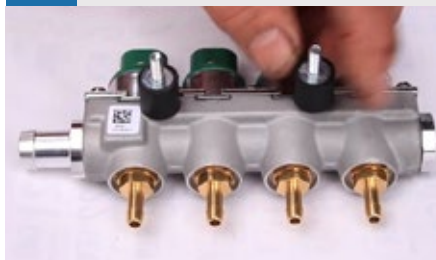
2

Fixation of the anti-vibration mounts

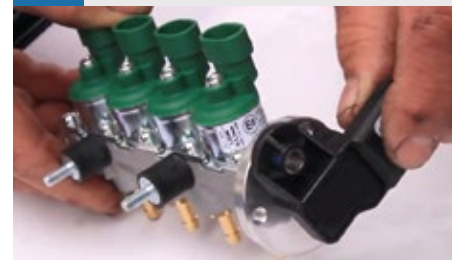
3

Installation of the pressure sensor

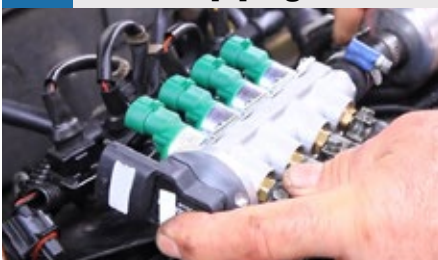
4

Connection of the piping

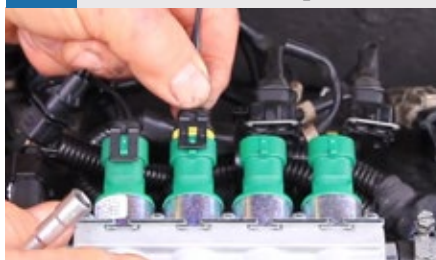
5

Connection of the electrical components

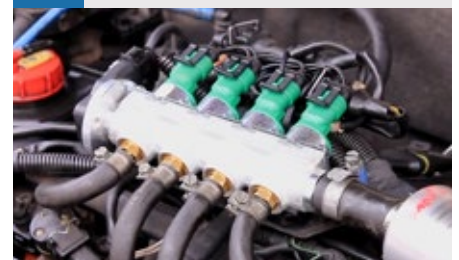
6

Correctly installed manifold

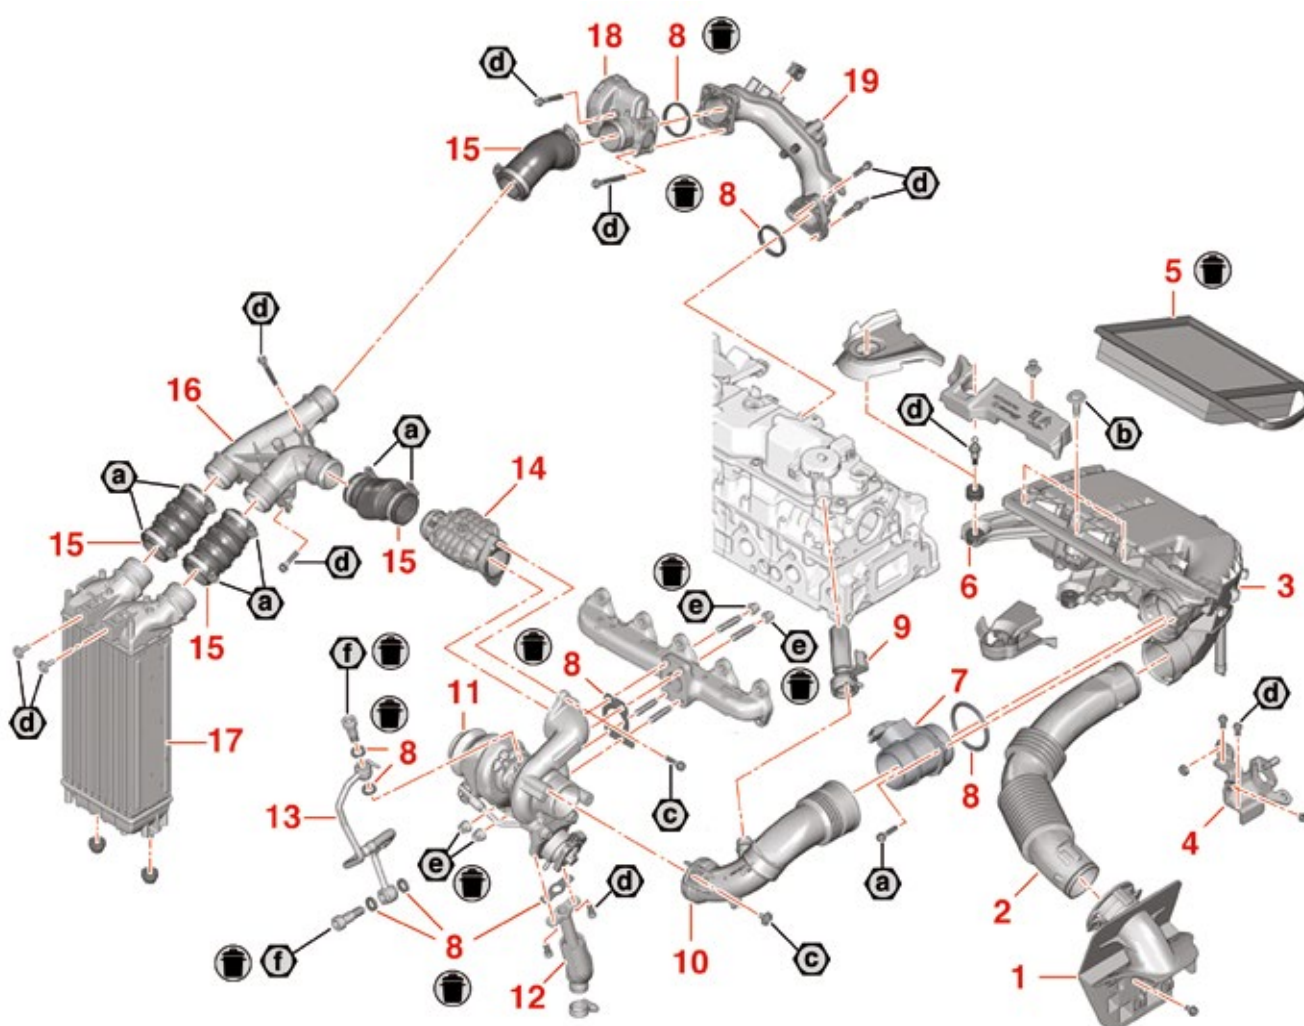
1. Air inlet
2. Air channel
3. Air filter case
4. Air filter case socket
5. Air filter
6. Silent block
7. Mass flow sensor
8. Gasket
9. Suction sleeve for the oil fumes
10. Turbocharger air intake pipe

11. Turbocharger
12. Turbocharger oil feedback pipe
13. Turbocharger oil intake pipe
14. Noise dampener
15. Sleeve
16. Supercharging air pipe
17. Air-to-air intercooler
18. Engine positioner
19. Air intake connection pipe

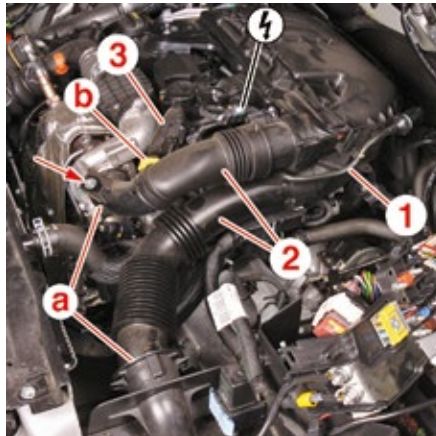
Pic. 22

- Disconnect the battery.
- Without disconnecting the pipes, move the brake liquid tank.
- Unplug the vacuum pipe (1) (Pic. 22).
- Separate:
 - the air pipes (2) at the end marked (a) on the sketch,
 - the oil vent (3) at the end marked (b).
- Remove the heat protection (4) from the air filter case (Pic. 23).
- Remove the air filter case by moving it backwards.

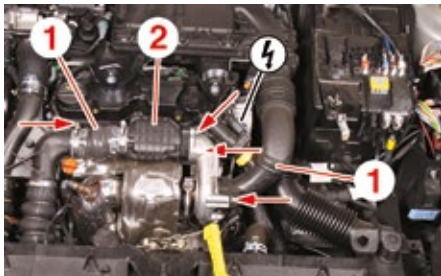
Pic. 24

- Disconnect:
 - the air pipes (1) (Pic. 24),
 - the noise dampener (2),
 - the oxygen sensor.
- Remove the heat protection (3) (Pic. 25).
- Disconnect the oil pipe (4), (Pic. 26).
- Disconnect:
 - the sleeve (5),
 - the air pipe (6) (Pic. 26).

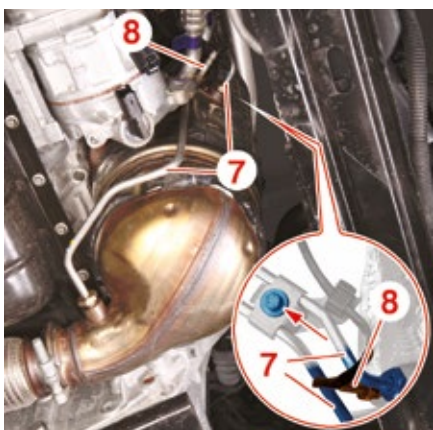
Pic. 27

- Move (Pic. 27):
 - the piping (7),
 - the probe (8).

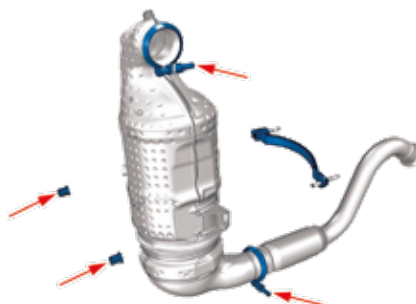
Pic. 28

- Detach the particle filter/catalytic converter (Pic. 28).

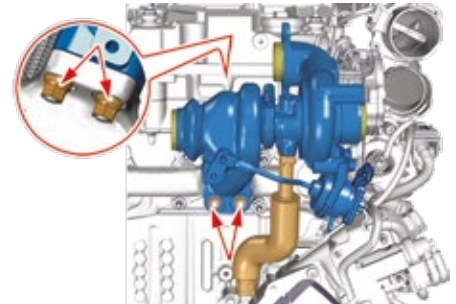
Pic. 29

- Detach the turbocharger (Pic. 29).

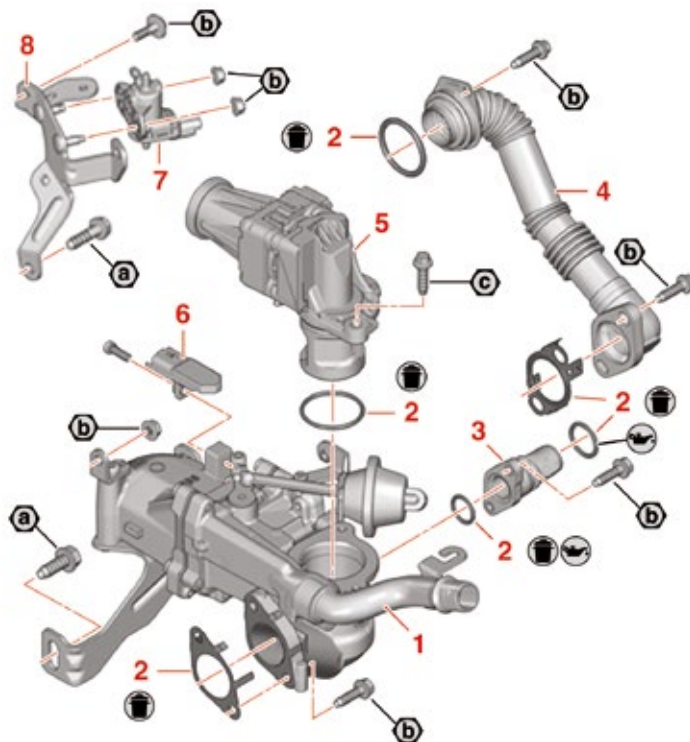
1. Module for reusing exhaust gases
2. Joint
3. Connection
4. Circuit
5. EGR valve
6. Sensor of the position of the actuator for the cooling of the reused gasses
7. Electrovalve for cooling reused gasses
8. Support for the electrovalve for cooling reused gasses

- a. 2 daN.m
- b. 0,8 daN.m
- c. 1 daN.m

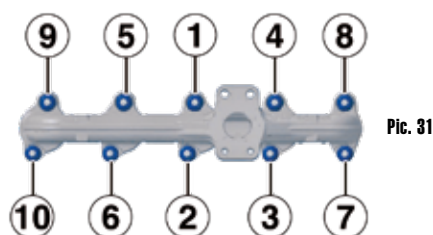
Pic. 31

- Fix the part in the following order (Pic. 31)

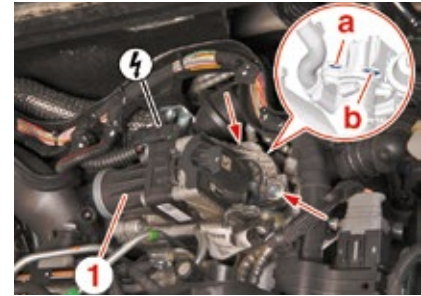
Pic. 32

- Remove the air filter casing (refer to corresponding operation).
- Separate the vacuum pump's depression connections.
- Dismantle the EGR valve **(1)** with a screwdriver as for **(a)** and **(b)** (Pic. 32).

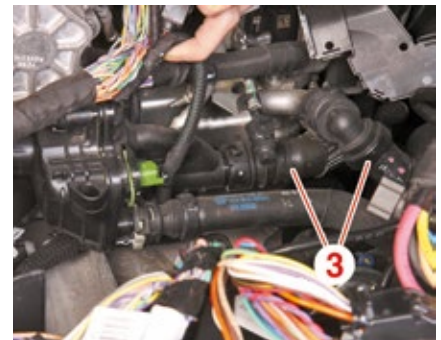
Pic. 34

- Disconnect the sleeves **(3)** (Pic. 34).

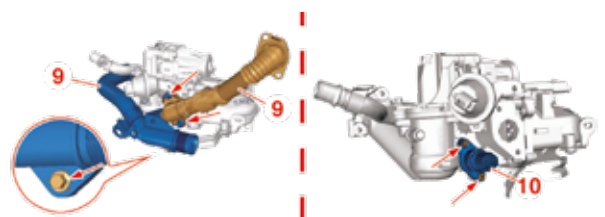
Pic. 37

- At the engine bench, disconnect (Pic. 37):
 - the piping **(9)**,
 - the connection **(10)**.

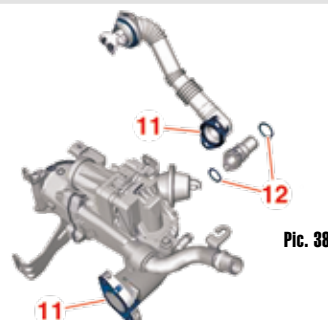
Pic. 38

- To reconnect, follow the same procedure from bottom to top.
- Be mindful of the following details:
 - Keep the positioning of the joint fixation rods **(11)** (Pic. 38).
 - Lubricate the joints with engine oil **(12)**.
